RAIN LEAK DETECTION AND POST-REPAIR INSPECTION WITH FLIR THERMAL IMAGING

USING THERMAL TO VISUALIZE LEAKS FOR CUSTOMERS

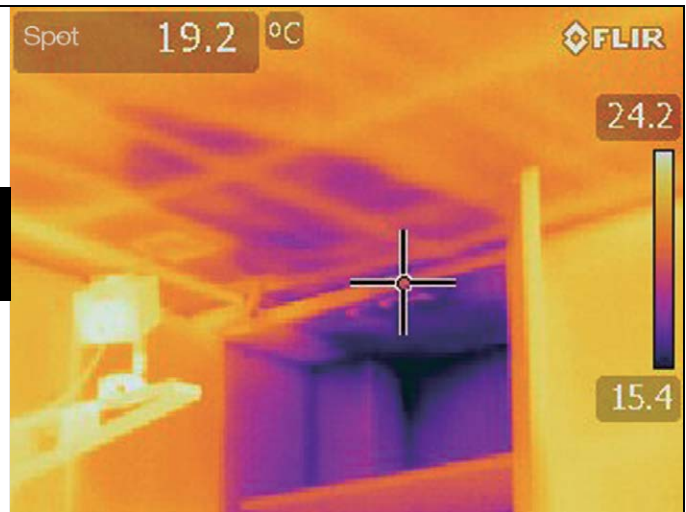
Thermal images shot during rain leak checks. FLIR thermal imaging cameras have high sensitivity, so both the water required and the testing time are minimized.

In fact, compared to other cameras he had tried, the FLIR E50bx was far more sensitive and performed much better in real-world scenarios. When walls and ceilings were wetted, the E50bx quickly sensed a change in temperature, reducing testing time and the amount of water needed before a leak could be visualized. Other products were slow to sense a

The FLIR E50bx is still the camera they use to identify internal rain leaks and intrusion paths, as well as to check repairs. The company conducts water intrusion tests before and after a repair, and can take more than 100 thermal images in the process. These images are used not only to identify the causes of rain leaks and pinpoint the area that needs fixing, but also provide a way to explain to customers what the problem is and why a repair is needed.

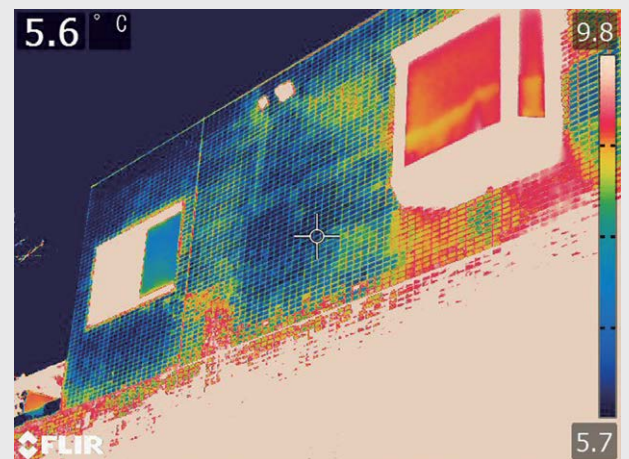
The cameras are also effective at finding external failures such as water leaks in siding.

The FLIR T620 is usually used to find external failures in buildings, like the uplifting of tiles, cold joints in mortar, and water leaks in siding. It’s not only effective as a non-contact tool to detect external wall defects, but it also provides a visual to help customers understand the risks posed by these faults. The company’s written reports always include thermal images, a practice that has helped them win large orders for rooftop repairs and full waterproofing of large-scale buildings.

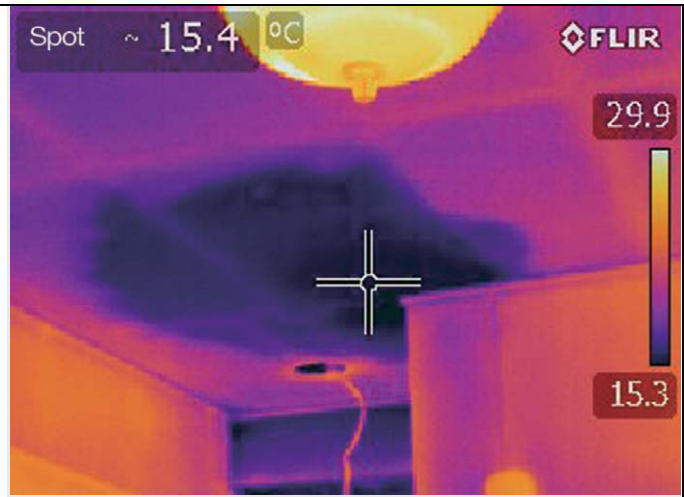
The thermal imaging cameras are useful in finding rain leaks that normally can't be seen.

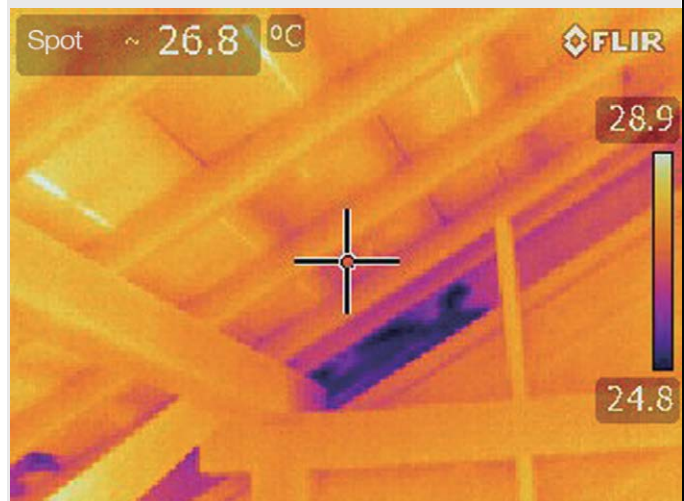
Showing customers thermal images taken before and after a repair helps convince them that the problem was solved, even in locations that are difficult to check, like the attic.

Another huge advantage of thermal cameras is that with the visuals provided by thermal images and moisture meters, customers can see for themselves that water leaks have been successfully repaired.

Thermal imaging has another advantage—even if in a few years a rain leak occurs in a different part of the building, customers know it's not the fault of the previous repair job. Shimura says they rarely receive complaints, because by seeing the thermal images themselves, customers can confirm that appropriate repairs were made during the previous job to stop the leak.
